Manhole Inspection Summary

Manhole # S25EE_024MH

Insp Date: **10/10/07 10:34 AM**

Location Address: **1304 LAURENS ST**

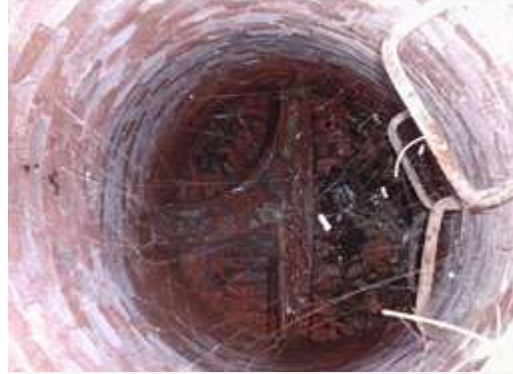
Top View

Corroded and missing steps. Bench debris.

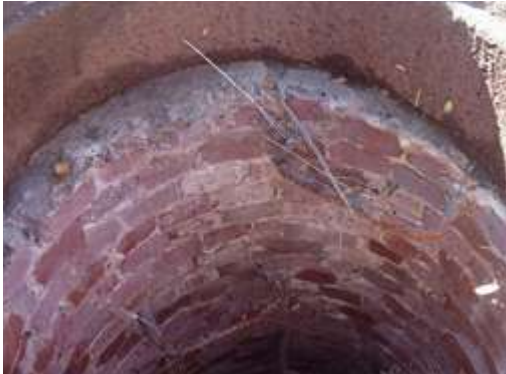
Defect

Frame offset. Adjustment deterioration and infiltration. Corbel and Barrel infiltration - other side.

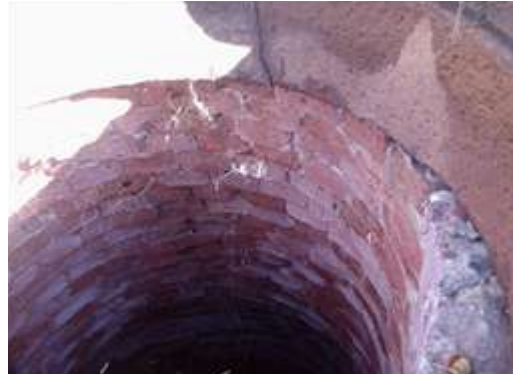
Defect

Frame leaks. Frame crack. Frame offset. Adjustment deterioration and infiltration. Corbel and Barrel infiltration.

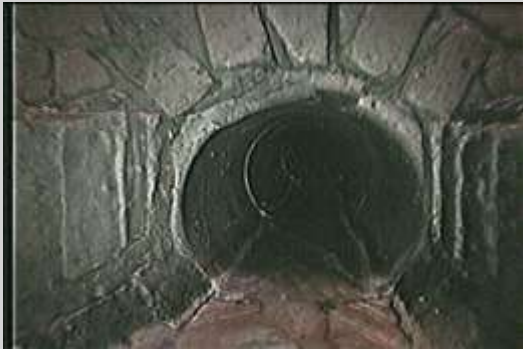
8 in. Circular Gravity Sewer Pipe Out @ 12 O'Clock

Infiltration: **Evidence** Pipe Seal Cond: **Broken**

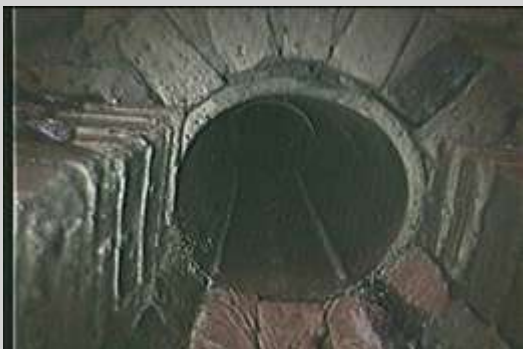
8 in. Circular Gravity Sewer Pipe In @ 6 O'Clock

Infiltration: **Evidence** Pipe Seal Cond: **Unknown**

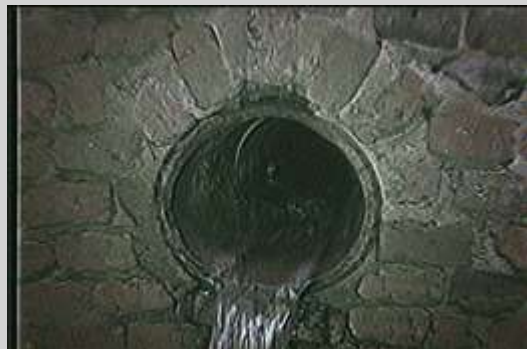
Pipe In @ 9 O'Clock

Infiltration: **Evidence**

Pipe Seal Cond: **Roots**

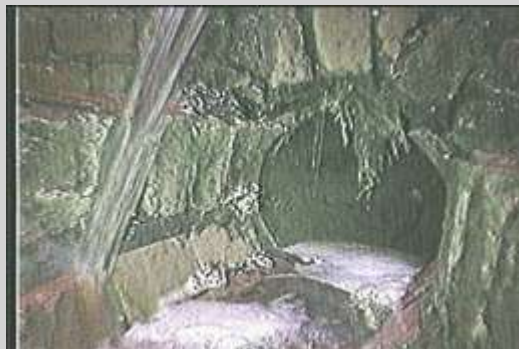
Drop In @ 9 O'Clock

Drop Condition: **Clogged**
